For Want of a Nail

The Wreck of the City of New Orleans

By Robert P. Schmidt

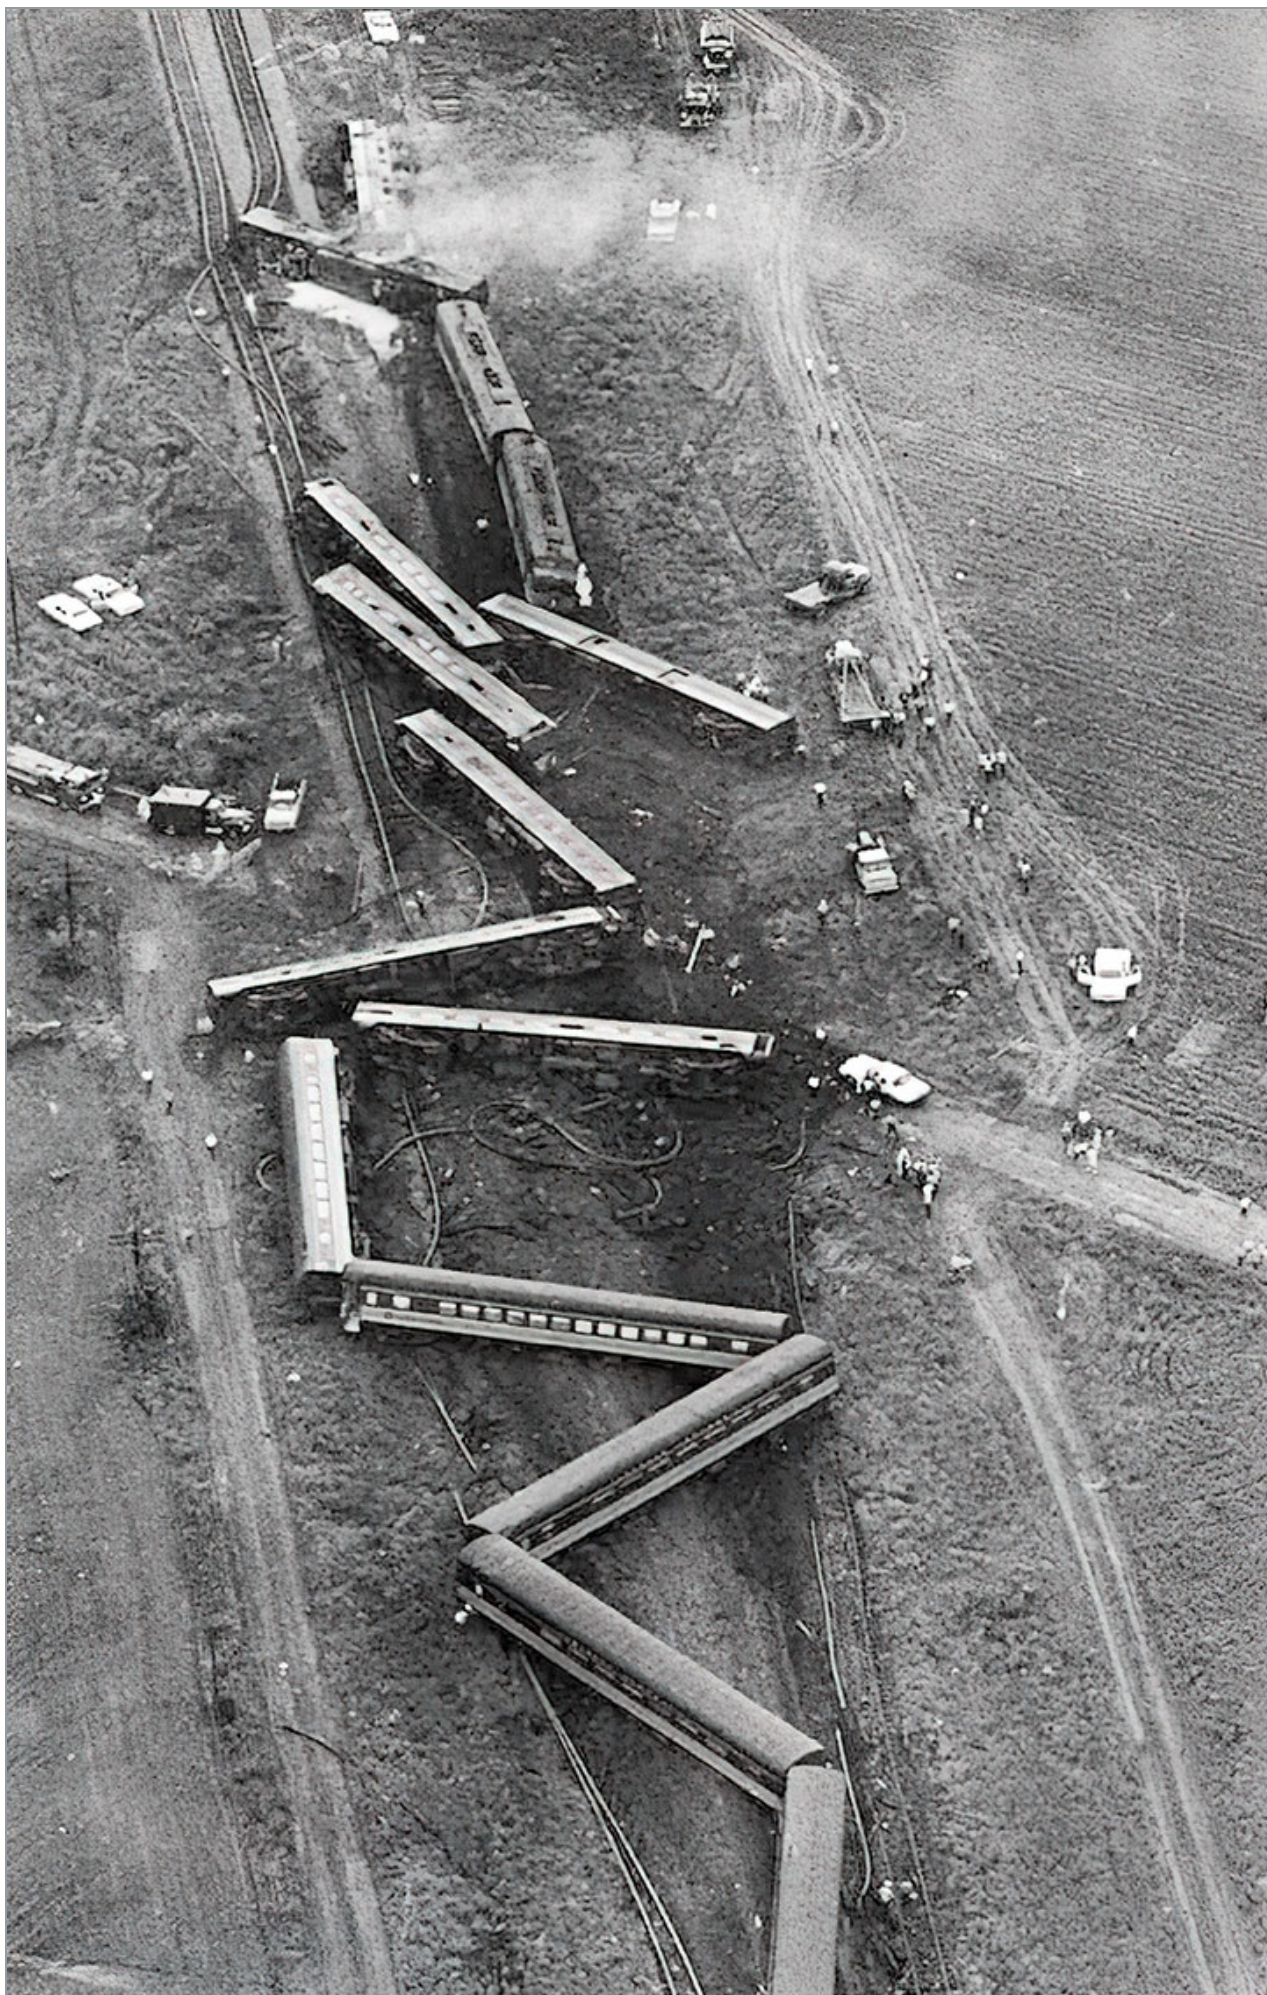
The derailed City of New Orleans near Tonti, Ill., was a jumbled mess and remains one of Amtrak's worst wrecks.

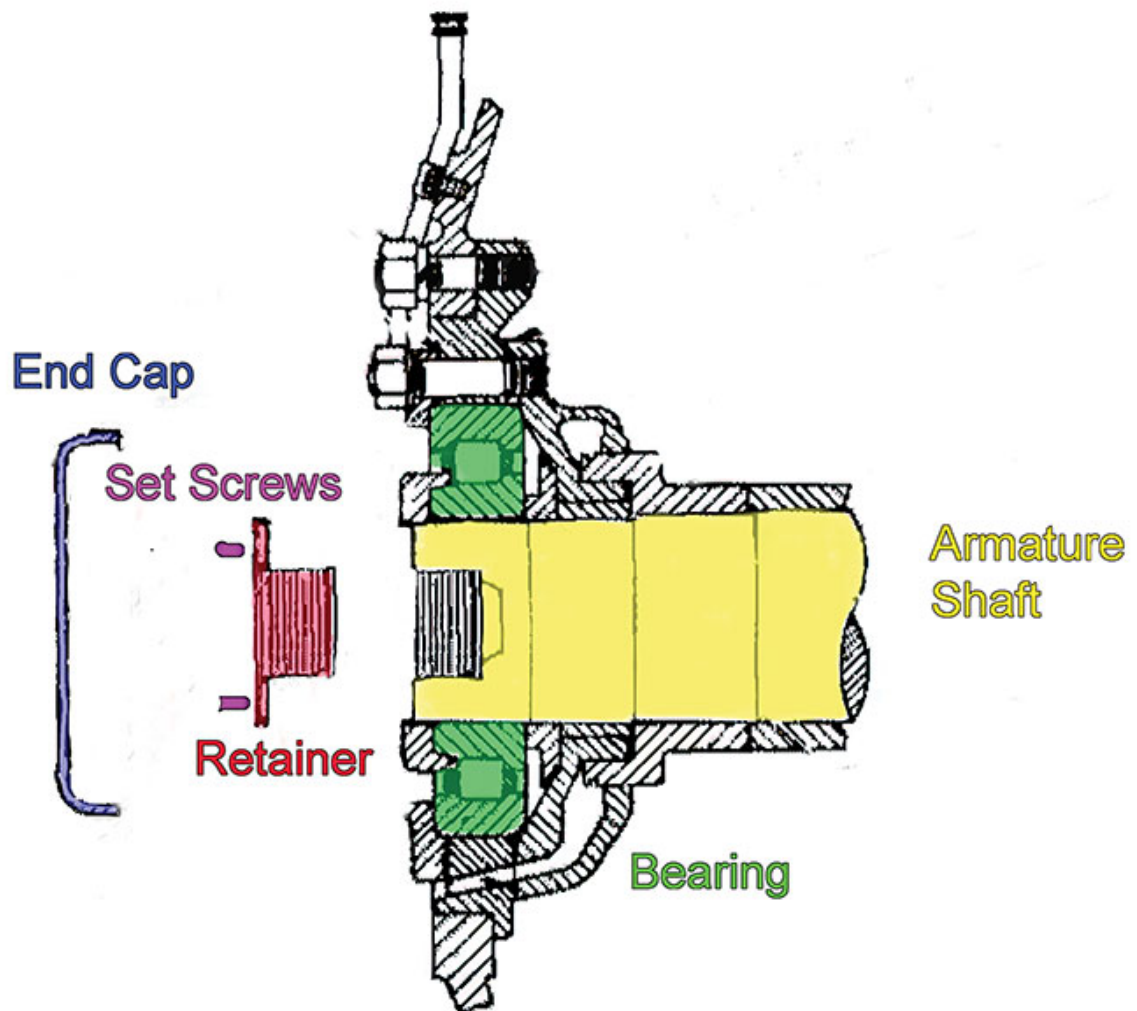
An exploded drawing of the bearing assembly at the commutator end of the armature shaft. The shaft (yellow in the drawing) is supported by the bearing assembly (green), which is held in place by the retainer (red). The retainer is anchored by two set screws (purple) and the whole assembly is covered by the end cap (blue).

4. Train 1 departed Chicago and headed southward with 204 passengers, 15 crew members, and three “deadheads” aboard. Somewhere along the way the friction between the threads of the screw-in plate and the armature shaft of the rebuilt traction motor failed to hold, and the retaining plate began to unscrew and back out. As it backed out it came into contact with the inside of the covering cap. Because of the direction the locomotive was traveling, the rotation between the plate and the cap caused the plate to unscrew even more. (If the locomotive had not been wyeed, the armature would have been spinning in the opposite direction and the rotation of the armature shaft would have had the effect of trying to screw the plate back into place.) As it was, the plate was trying very hard to unscrew and back out, but had no place to go. This exerted a tremendous lateral force in the direction of the pinion end on the parts relating to the armature shaft, especially the bearings. These bearings are designed to withstand substantial vertical and rotational forces, but lateral forces should be negligible. The normal tolerance for lateral movement was less than 0.011 inches. Quickly, the threads on the plate and the shaft were stripped and the lateral force was released, but in the process the brass cage holding the bearings in place had been damaged and the bearings had become badly misaligned.

If any of the eight mishaps listed above had not happened, this catastrophe would not have occurred. Each by itself was highly improbable—together they were deadly. “Murphy’s Law” states, “Anything that can go wrong, will go wrong.” In this instance, Murphy was an optimist. But the principal proximate cause of the tragedy was someone’s failure to tighten just two little set screws.

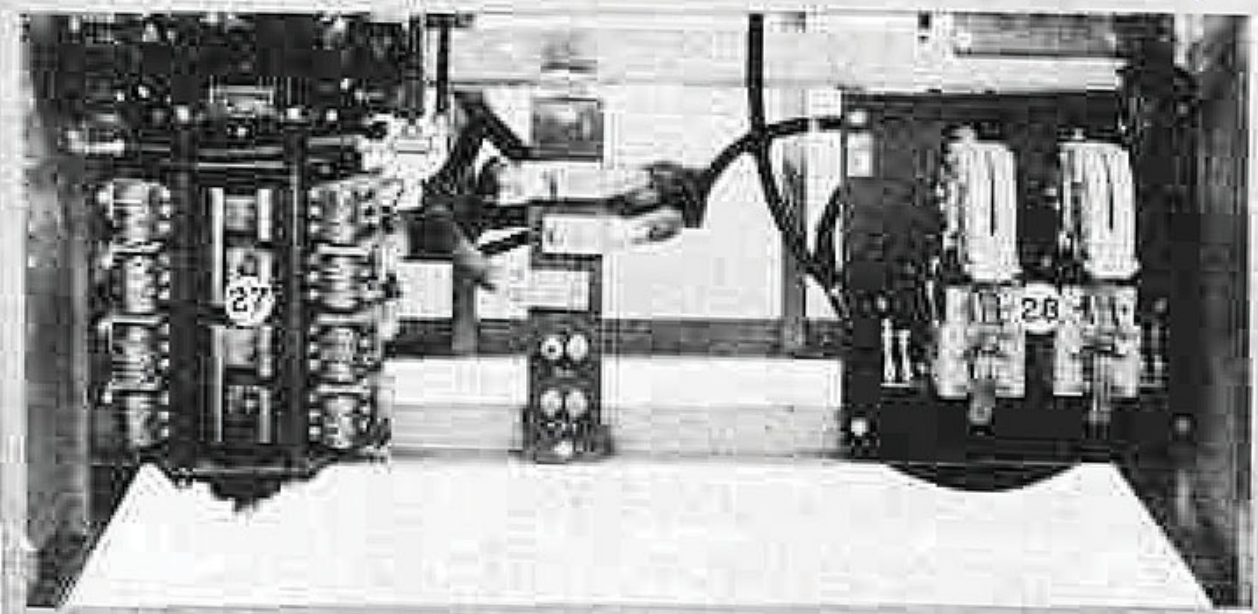
Reverse Current Relay

1. Each diesel engine drives an auxiliary generator, producing direct current to charge the storage batteries and supply the low-voltage circuits for lighting, control, etc. While southbound train number 1 was on its way to New Orleans on June 7, the crew had noticed that the auxiliary generator driven by the rear diesel engine of 4031 was not operating properly. Therefore, that engine was shut down and the “Reverse Current Relay” switch in the electrical cabinet relating to that engine was placed in the neutral position, locked in that position by a pin, and given a yellow tag to alert everyone that this engine/generator/motor set was not functioning.

2. Illinois Central did not have adequate facilities in New Orleans to repair the auxiliary generator, so the locomotive was dispatched back to Chicago as part of train 2, the northbound City, and then sent to Woodcrest Shops. Workers there replaced the auxiliary generator but, somehow, they overlooked the pinned reversing circuit despite the fact that this condition was noted on the

The electrical control cabinet for the rear engine of an E8 locomotive. The “Reverse Current Relay” is shaded in red.
-EMD, Preston Cook collection

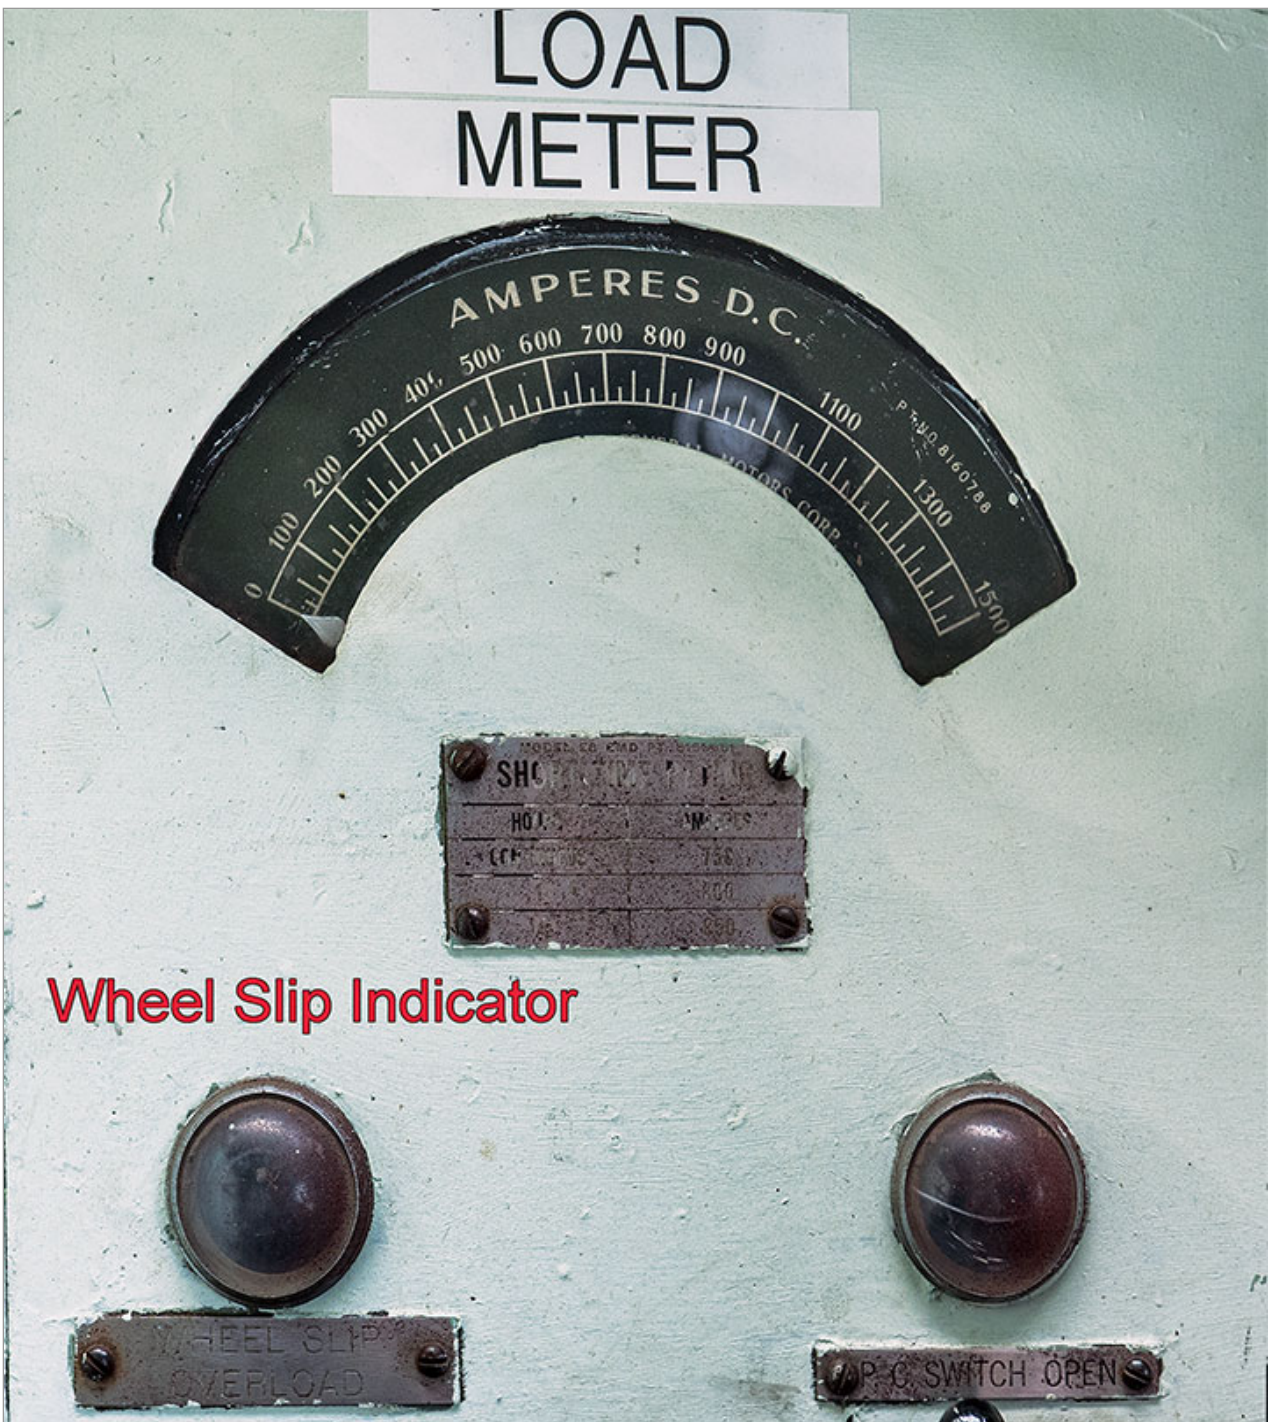
Wheel Slip Indicator

Some of the displays visible to the engineer, including the “Load Meter” and the “Wheel Slip Indicator.”

appeared to the engineer to be normal. The power discrepancy might have been shown by the “Load Meter” in the cab, except that this gauge was designed to show only power going to the front truck, which was operating normally. The locomotive crew knew that although the number 2 engine was running and “on line,” it was not “loading” (supplying power to the motors), but they did not know why or understand the possible implications. At the controls was Lacy Haney, a 24-year veteran locomotive engineer who testified that in all that time he had never experienced a sliding wheel. The train passed railroad employees on the ground at Effingham Yard and at Edgewood, plus track gangs along the way, but the high sound levels and the cloud of dust around the trucks as the train was traveling more than 90 mph probably obscured the sound of the dragging wheels and the sight of whatever sparks were being thrown off. But the most important device to warn about the possibility of sliding wheels was the “wheel slip indicator,” a light on the stand in front of the engineer that would illuminate if there was a current differential between the traction motors, which would indicate that one set of wheels was either slipping or sliding. However, because the reverser on the Number 2 engine was pinned in neutral, no current was reaching the wheel slip indicator circuits so the indicator was not responsive to the problem with respect to these wheels. The EMD Operating Manual failed to mention this possible condition. In short, the crew in the cab simply did not know what was happening to the motor.

The issue of providing adequate independent wheel slip/slide detection for locomotives proved to be more difficult. In order to be most effective, it required a solution separate from the previous technology. This was particularly true for situations where the locomotive or one engine of a twin-engine locomotive might be shut down en route due to equipment problems, thus rendering the traction motor dependent wheel-slip detection inoperative. The accident report made note of an existing loophole in the federal regulations at that time, by which the powered axles of a locomotive were not considered to be powered anymore, if the engine providing the power was shut down en route. This curious contradiction created a situation where there was, in effect, no actual rule requiring working wheel slip/slide protection for a cut-out traction motor or unpowered axles.

The situation dictated the need for a new form of wheel slide protection that would be functional in all situations and would be completely independent of the powered transmission system of a locomotive. EMD developed such a device for the incoming Dash-2 electrical system that would be subsequently employed in the Amtrak SDP40F and F40PH locomotives. The LW (Locked Wheel) detection system continuously compared signals generated by magnetic pickups monitoring the rotation of a toothed wheel on each traction motor armature. If the difference in signal between the motors exceeded a threshold that allowed for minor differences in wheel size and temporary wheel slip conditions, the locked wheel detection

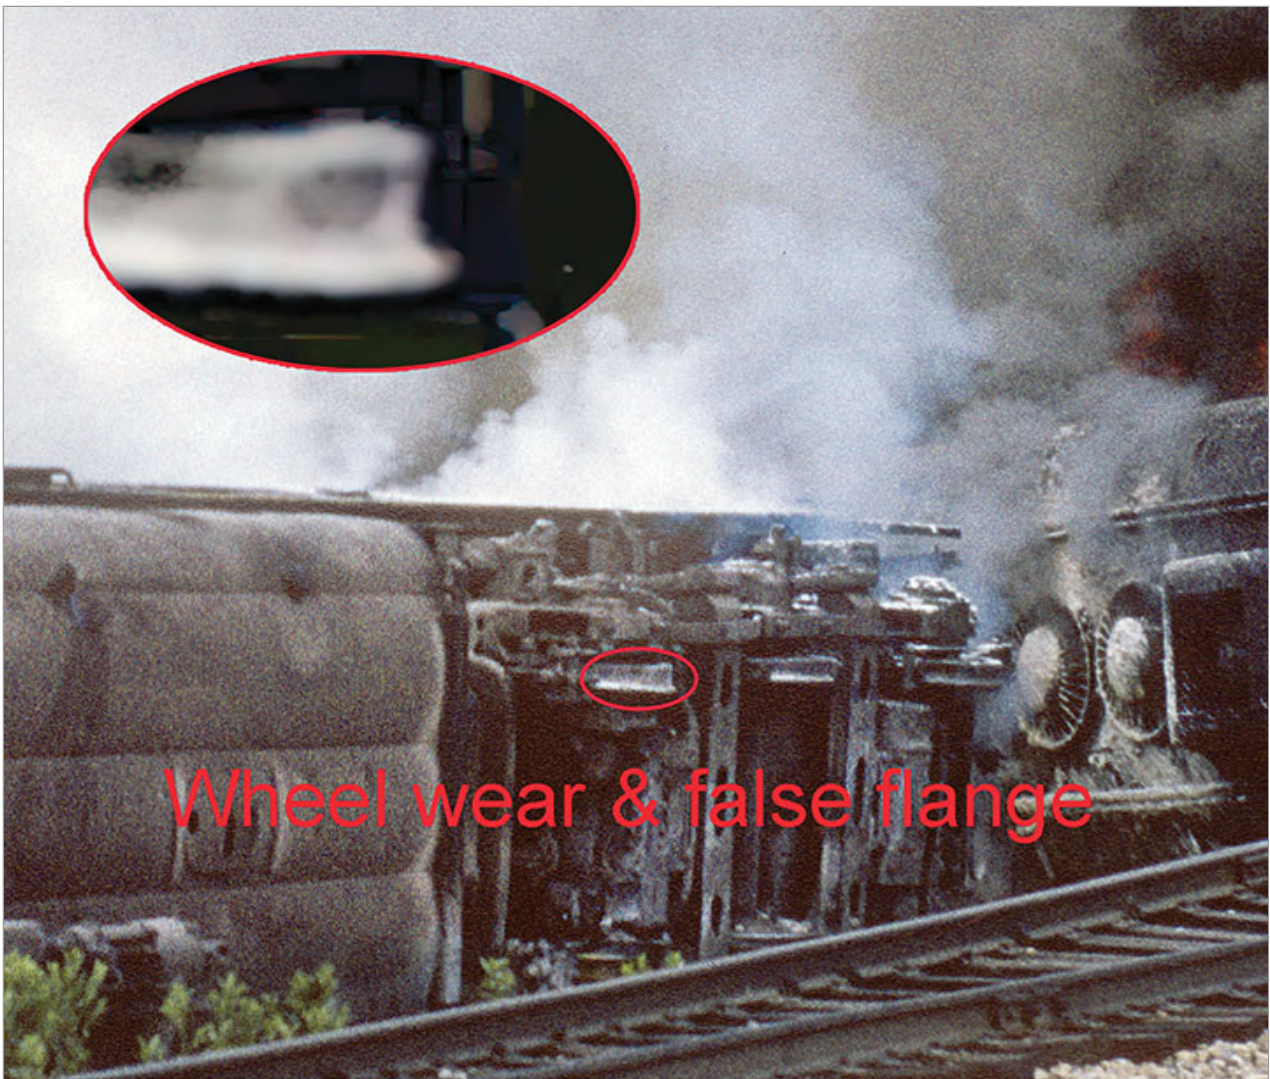
A greatly enlarged photo of the rear truck of Locomotive 4031, lying on its side, taken at the crash site. This extreme magnification is not tack-sharp, but the flat spot and “false flange” on the wheel attached to the leading axle of this truck can be seen.

8. Train 1 continued southward in this condition for 27 miles at an average speed of 97 mph. During this time, the friction between the two locked wheels and the rails quickly caused extreme wear, close to ten inches long, of the wheels. The wear changed the geometry of the wheels and caused the build-up of a “false flange” on the field side of the wheels. When the false flange encountered a switch at Tonti, the wheels tried to go both ways, could not, and wound up off the rails.

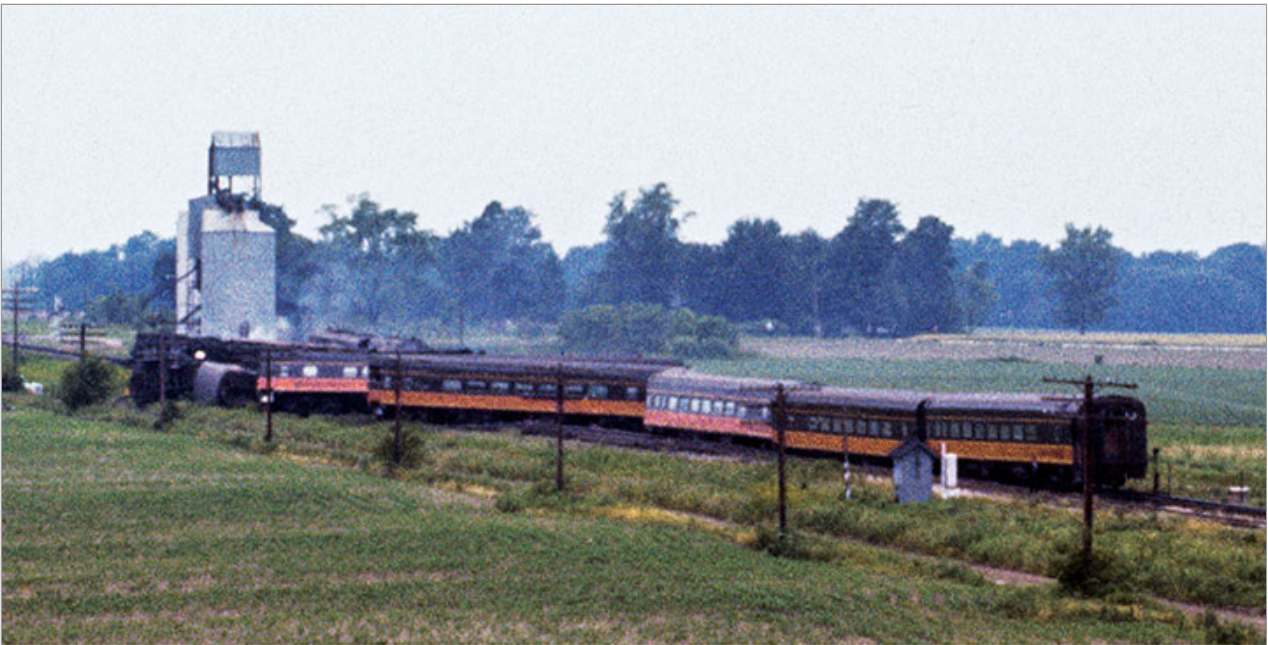
The wrecked City of New Orleans, as seen in this southwesterly view taken from Interstate 57 looking toward the village of Tonti. Both the photographer and a truck driver witnessed the derailment as it happened, with both exiting the Interstate and returning to the scene to help.

At this point all hell broke loose. Dick Gordon, of nearby Salem, Ill., was an eyewitness. “I was driving my truck over the Interstate viaduct across the tracks, and I looked down at the train passing beneath me. All of a sudden the engine started to weave back and forth, harder and harder, and then they all started to flip off the track, the cars piling up in a big cloud of dirt ... it was all over in ten seconds.”

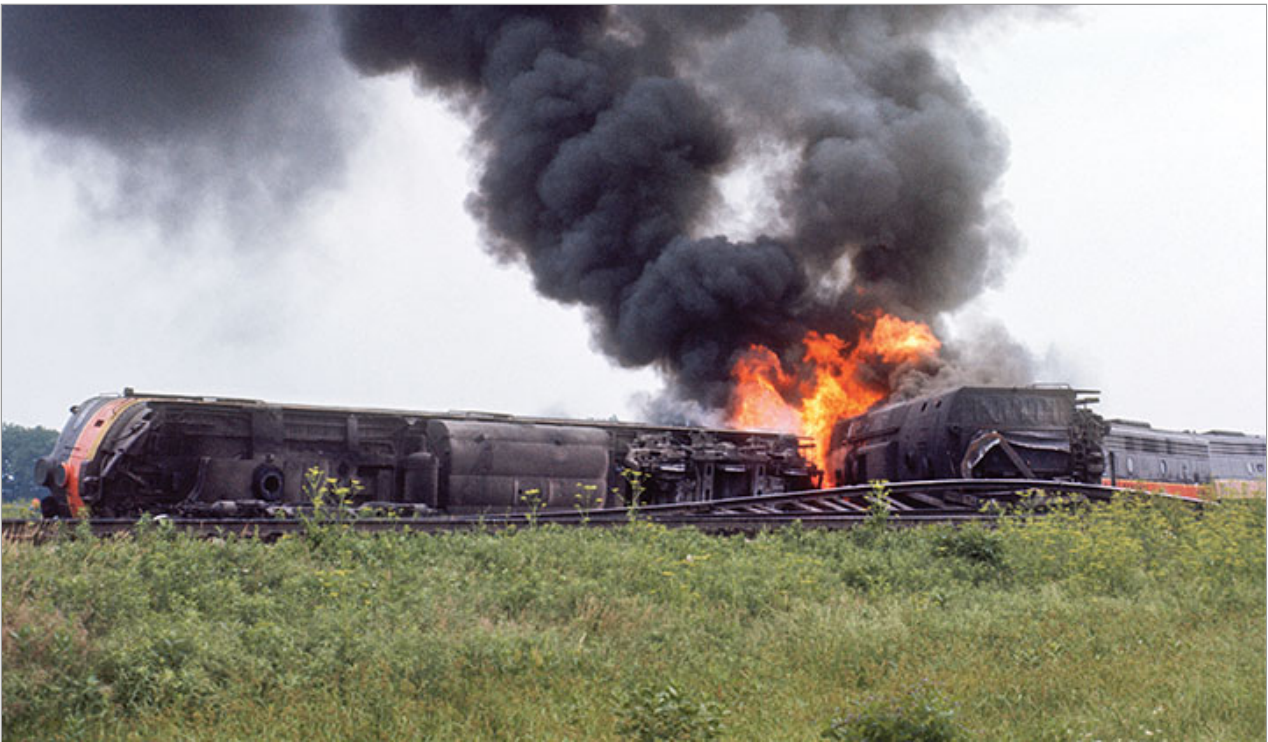
A fire—likely from leaking fuel—started in the second (of four) locomotive and spread to the lead E8, number 4031. Three or four E-units were commonly assigned to the City to maintain the train's impressive overall schedule, which had the train departing Chicago at 8am and arriving at New Orleans shortly after midnight.

The locomotives and the front half of the string of passenger cars turned on their sides and skidded along the ground for distances up to 400 feet. By some miracle the engineer and fireman survived, but the engineer was buried up to his waist in ballast materials that entered the cab. A fire started in the second diesel locomotive unit (E8B 4109), and spread to the 4031. The passenger cars headed in various directions, and the people inside were violently thrown about. Rails broke and penetrated the cars. One of these rails trapped a woman inside the car by pinning her dress, which had to be cut to free her. Windows were broken and several persons, including Conductor C. R. Fletcher, were thrown out; many of the fatalities wound up under the sides of the cars as they careened into a jumble.
