FROM
NOVEMBER
1984
TRAINS MAGAZINE

America's steepest mainline grade challenged generations of Southern Railway men

By Frank Clodfelter

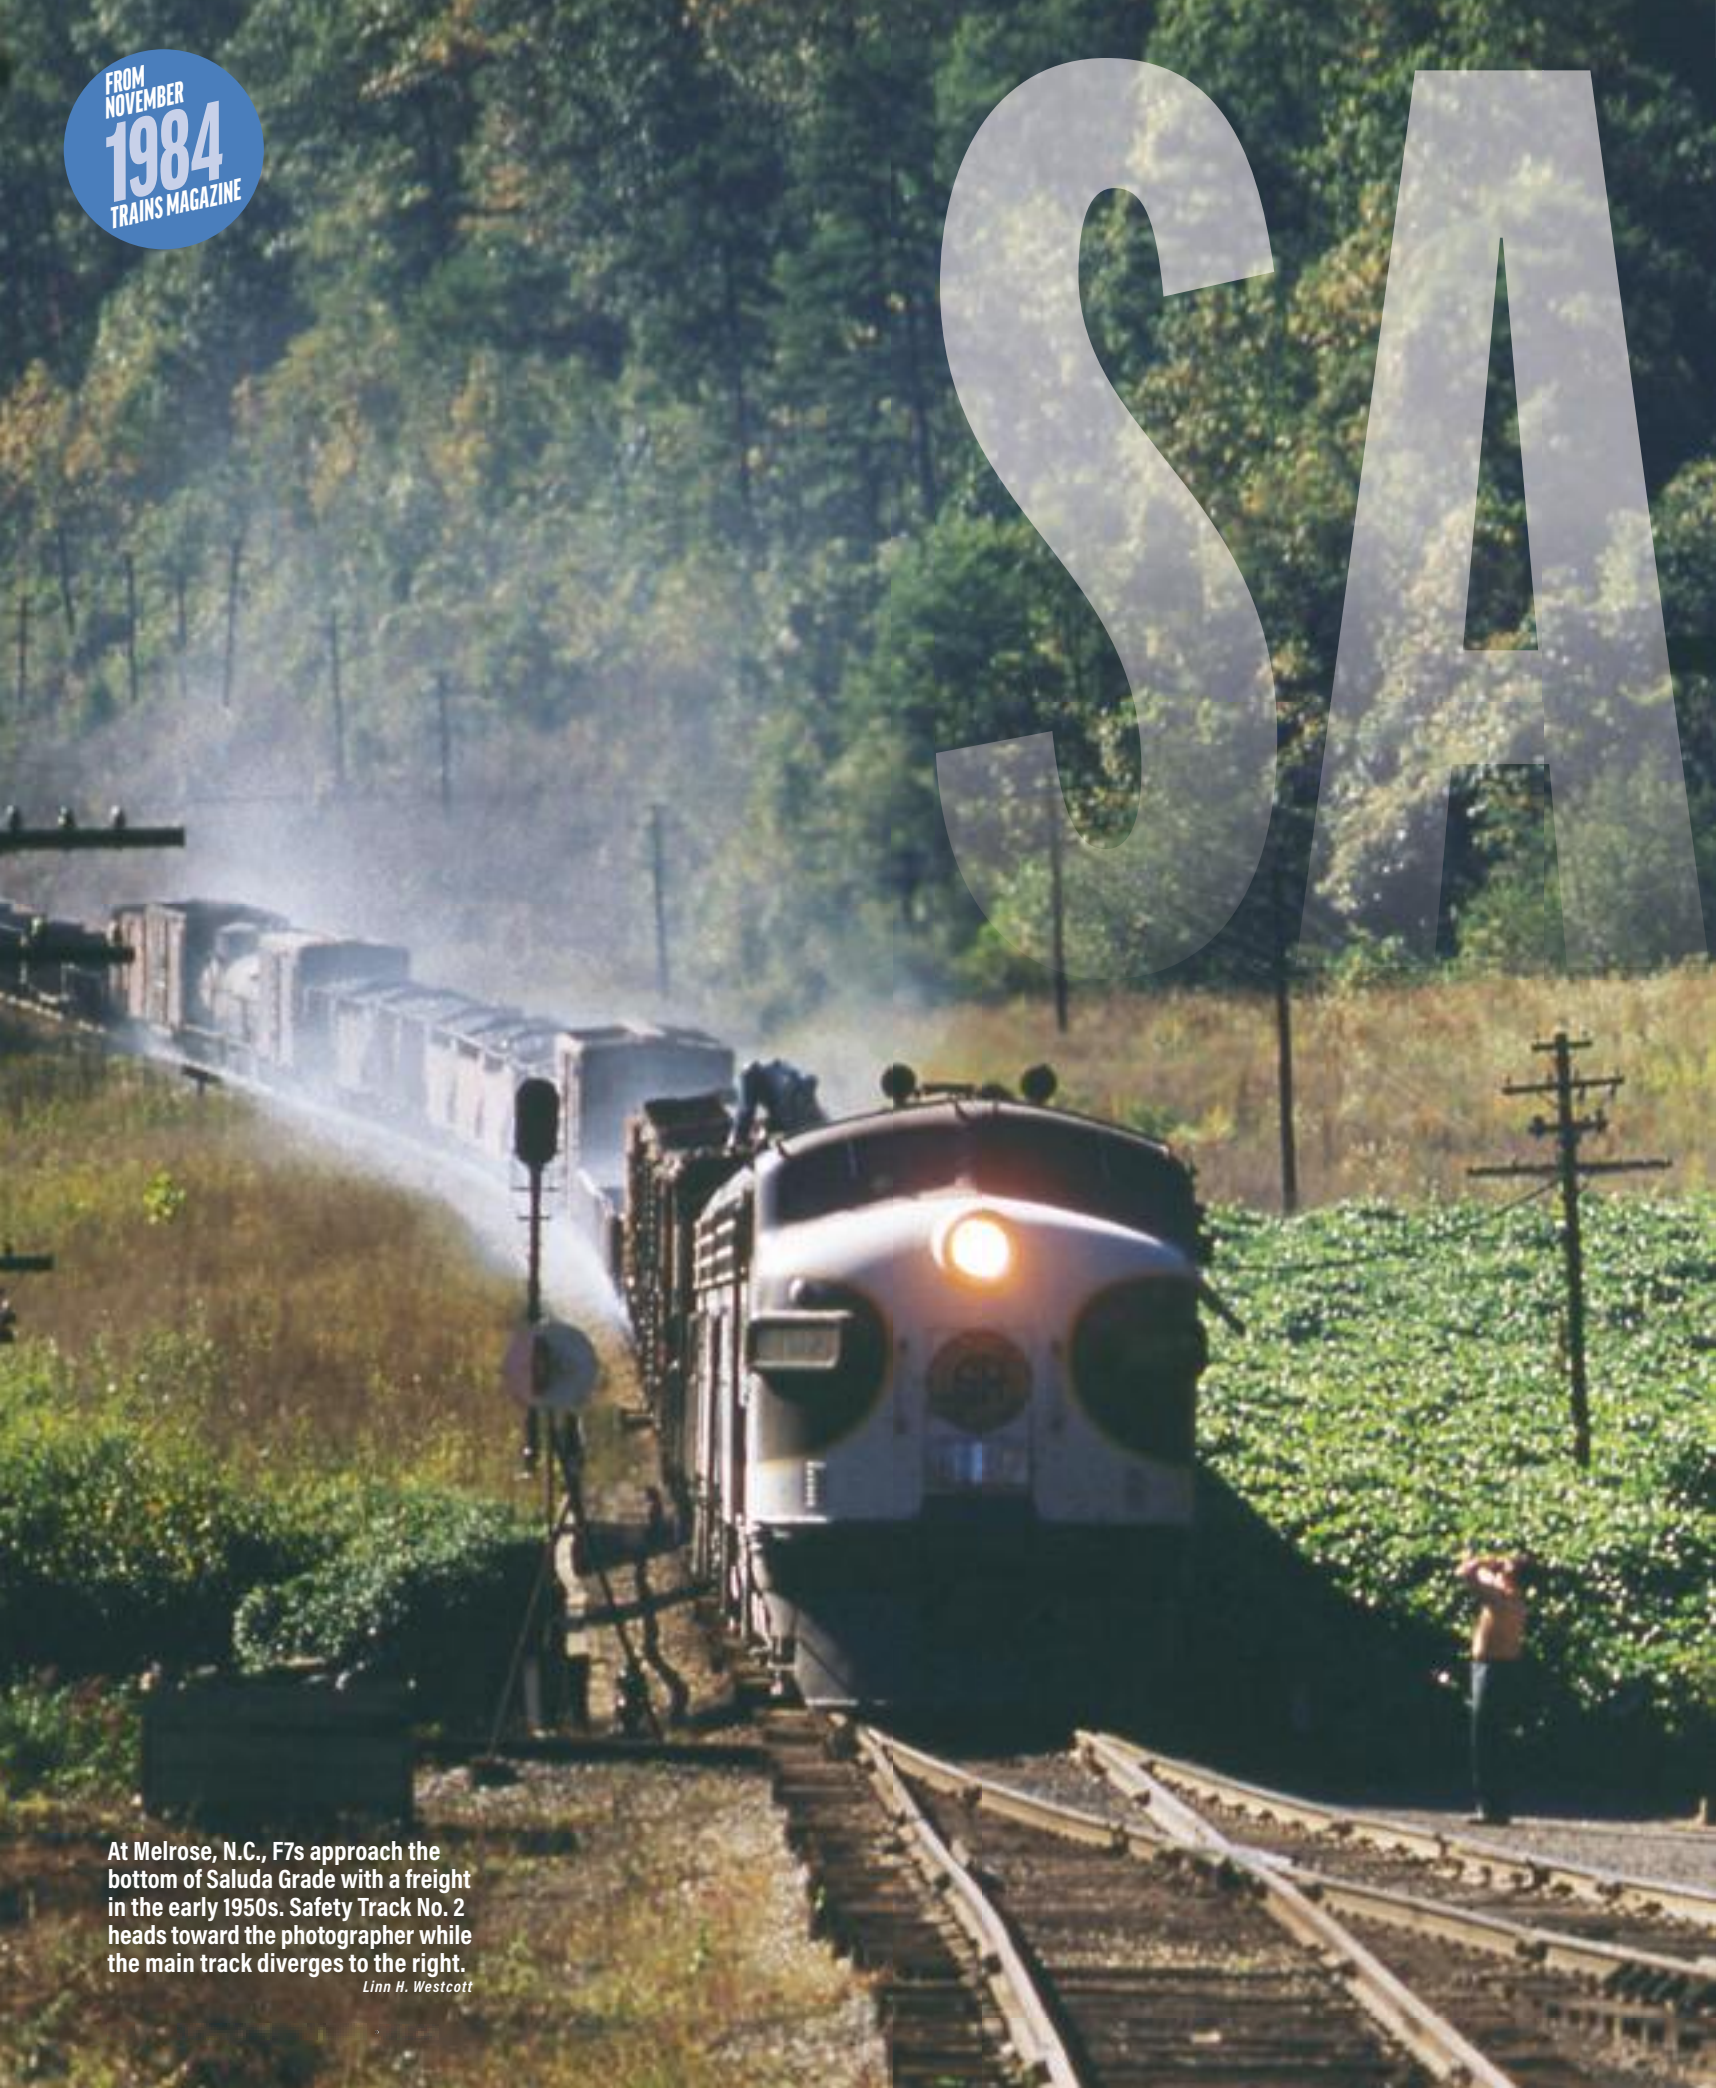
At Melrose, N.C., F7s approach the bottom of Saluda Grade with a freight in the early 1950s. Safety Track No. 2 heads toward the photographer while the main track diverges to the right.

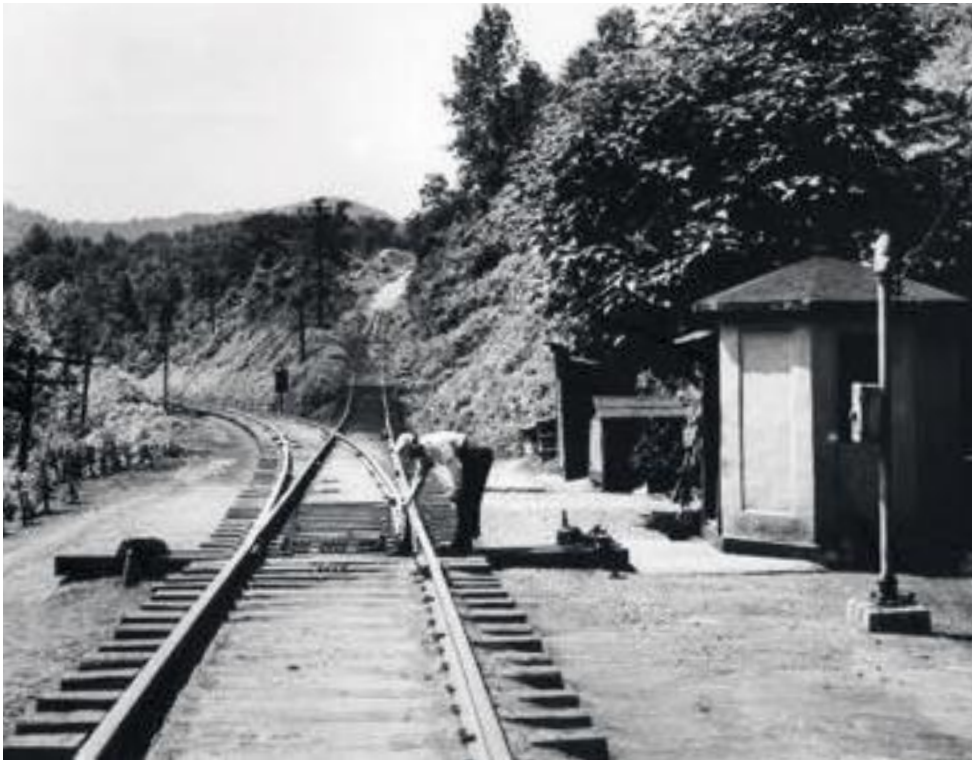
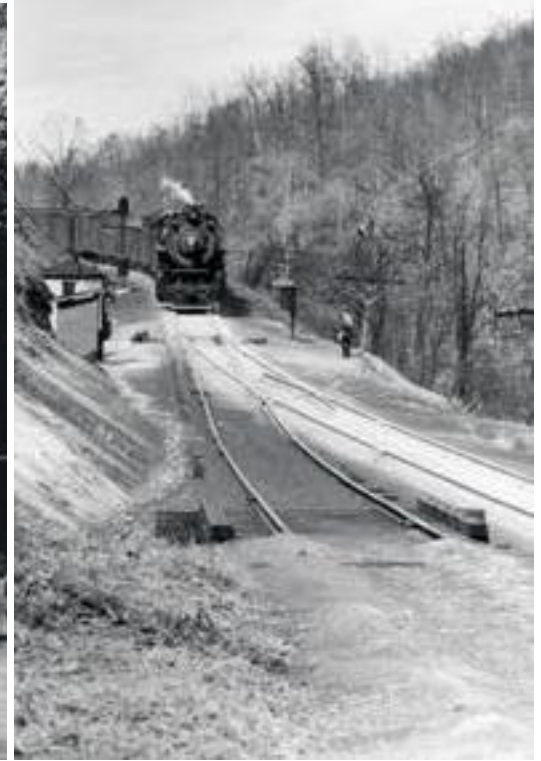
Switch tender R. A. Moody (above) cleans the points of Safety Track No. 1 in 1942. In another 1940s view but facing the opposite direction, the switch tender has lined the switch for the main line and stands aside as a train eases down the hill; the safety track's rails are heaped with sand to retard train speed.

According to the late E. B. Hall, former mayor of the town of Saluda and veteran operator there, Safety Track No. 1 was 1,080 feet long and was located 8,001 feet east of the depot. The grade ranged from 4.3 to 9.9 percent. At the end-of-track were anchored timbers chained to the rails and a mound of dirt 60 feet long, 14 feet wide, and 6 feet high. The track was heavily sanded.

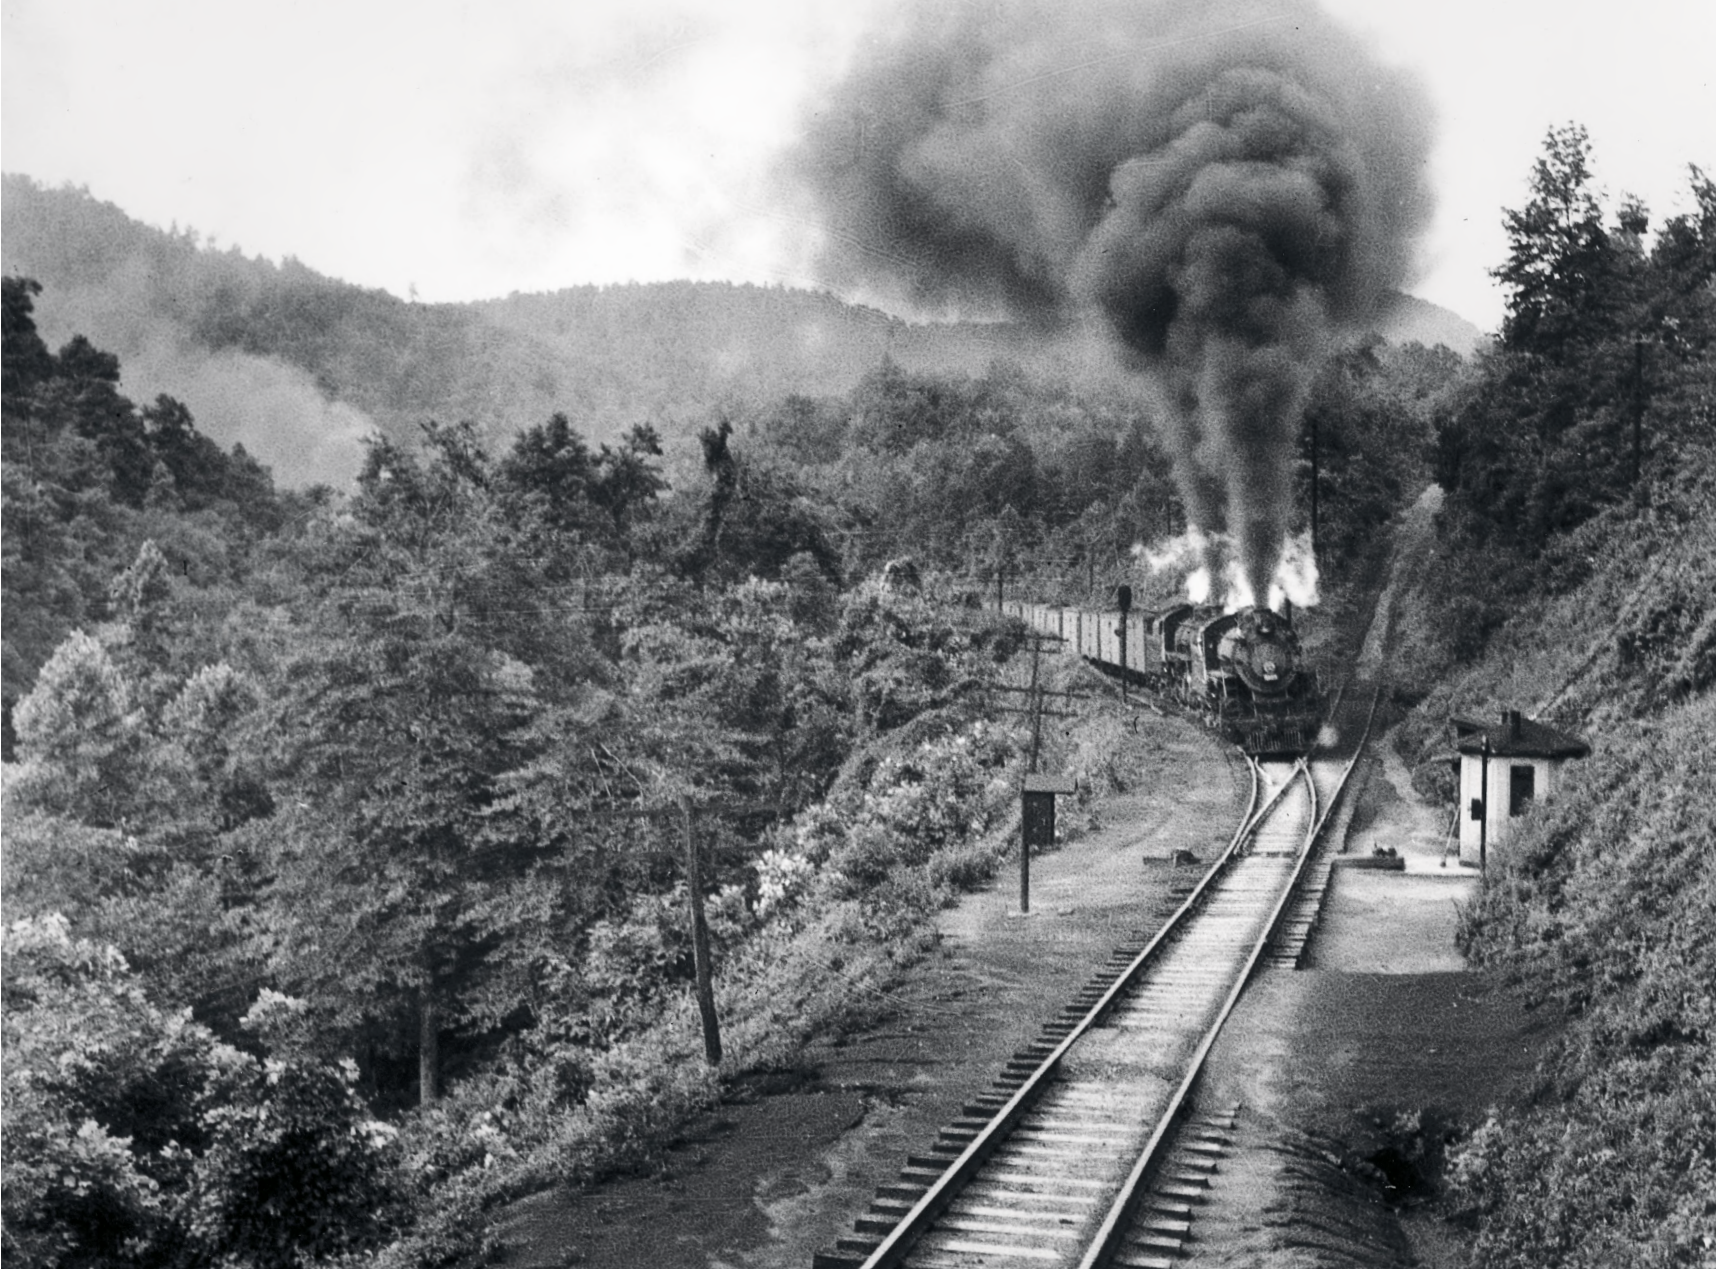
Two heavy Mikados, author Clodfelter's favorite Southern freight power, labor past Safety Track No. 1 with a train of reefers filled with peaches in the mid-1940s; smoke from a 2-10-2 pusher rises above the trees at left. This spur, considered superfluous in the diesel age, would be removed in the early 1950s.

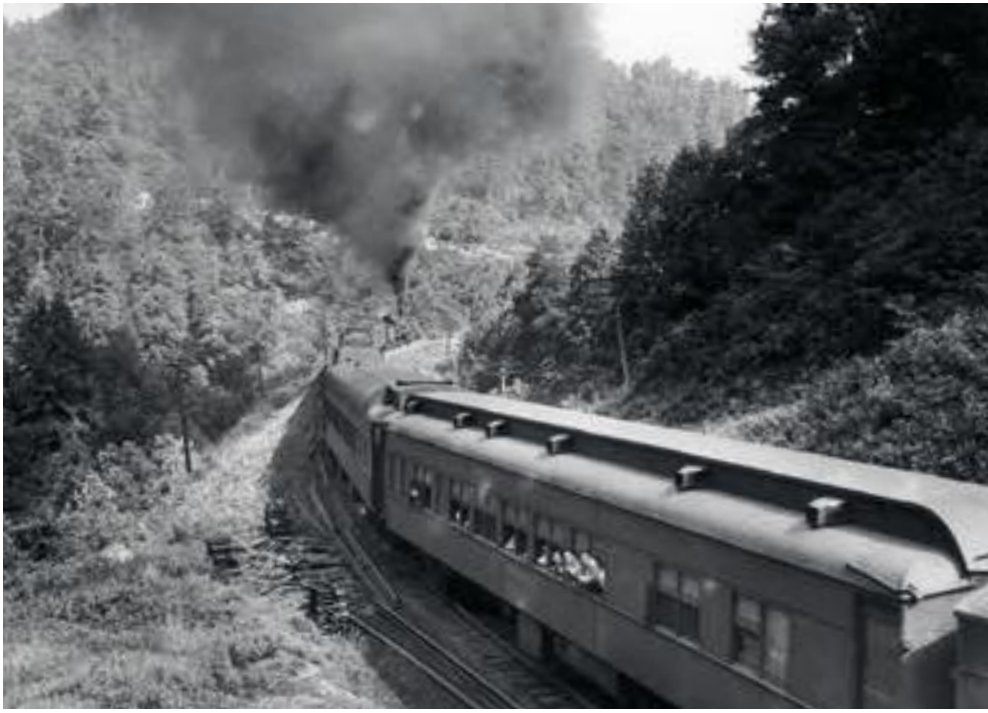
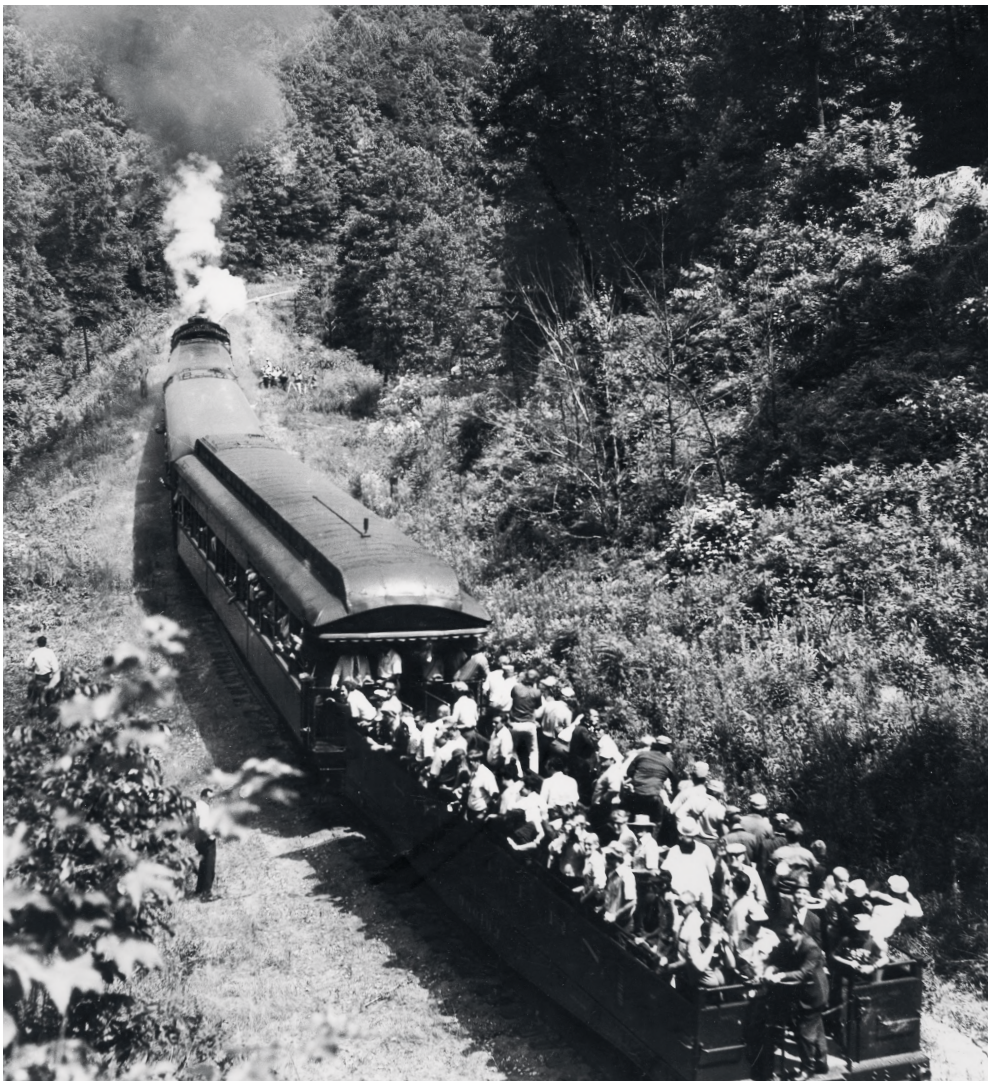
Sand Cut scenes: Troops wave from their Pullman (top) as a 2-8-2 hauls the *Skyland Special* up the hill during World War II; Safety Track No. 1 cuts across the mountain above the engine. Three decades later, fantrip Mikado 4501 heads up with a four-car Spartanburg-Asheville excursion on July 8, 1972.

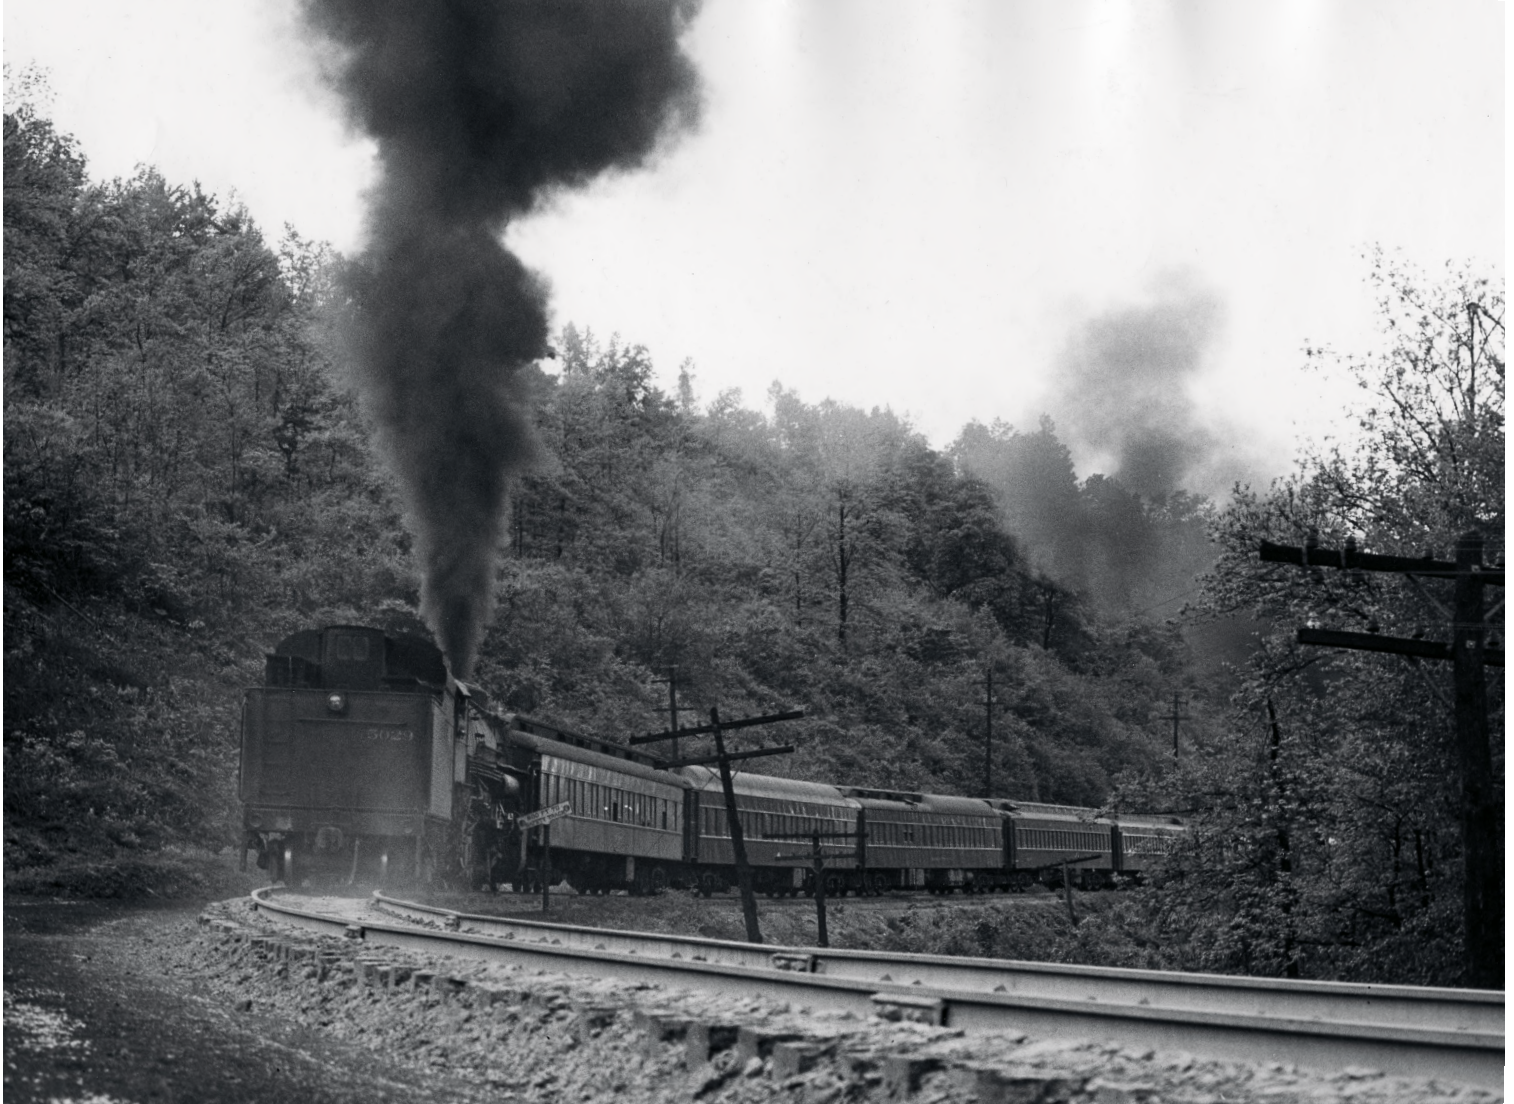
On the 10-degree curve just above Sand Cut, 2-10-2 No. 5029 shoves on the rear of the *Carolina Special* in April 1947. The angled sign to the right of the engine indicates that the switch for Safety Track No. 1 is 800 feet ahead. Specially modified for the hill, class Ss engines were Saluda fixtures until the end of steam.

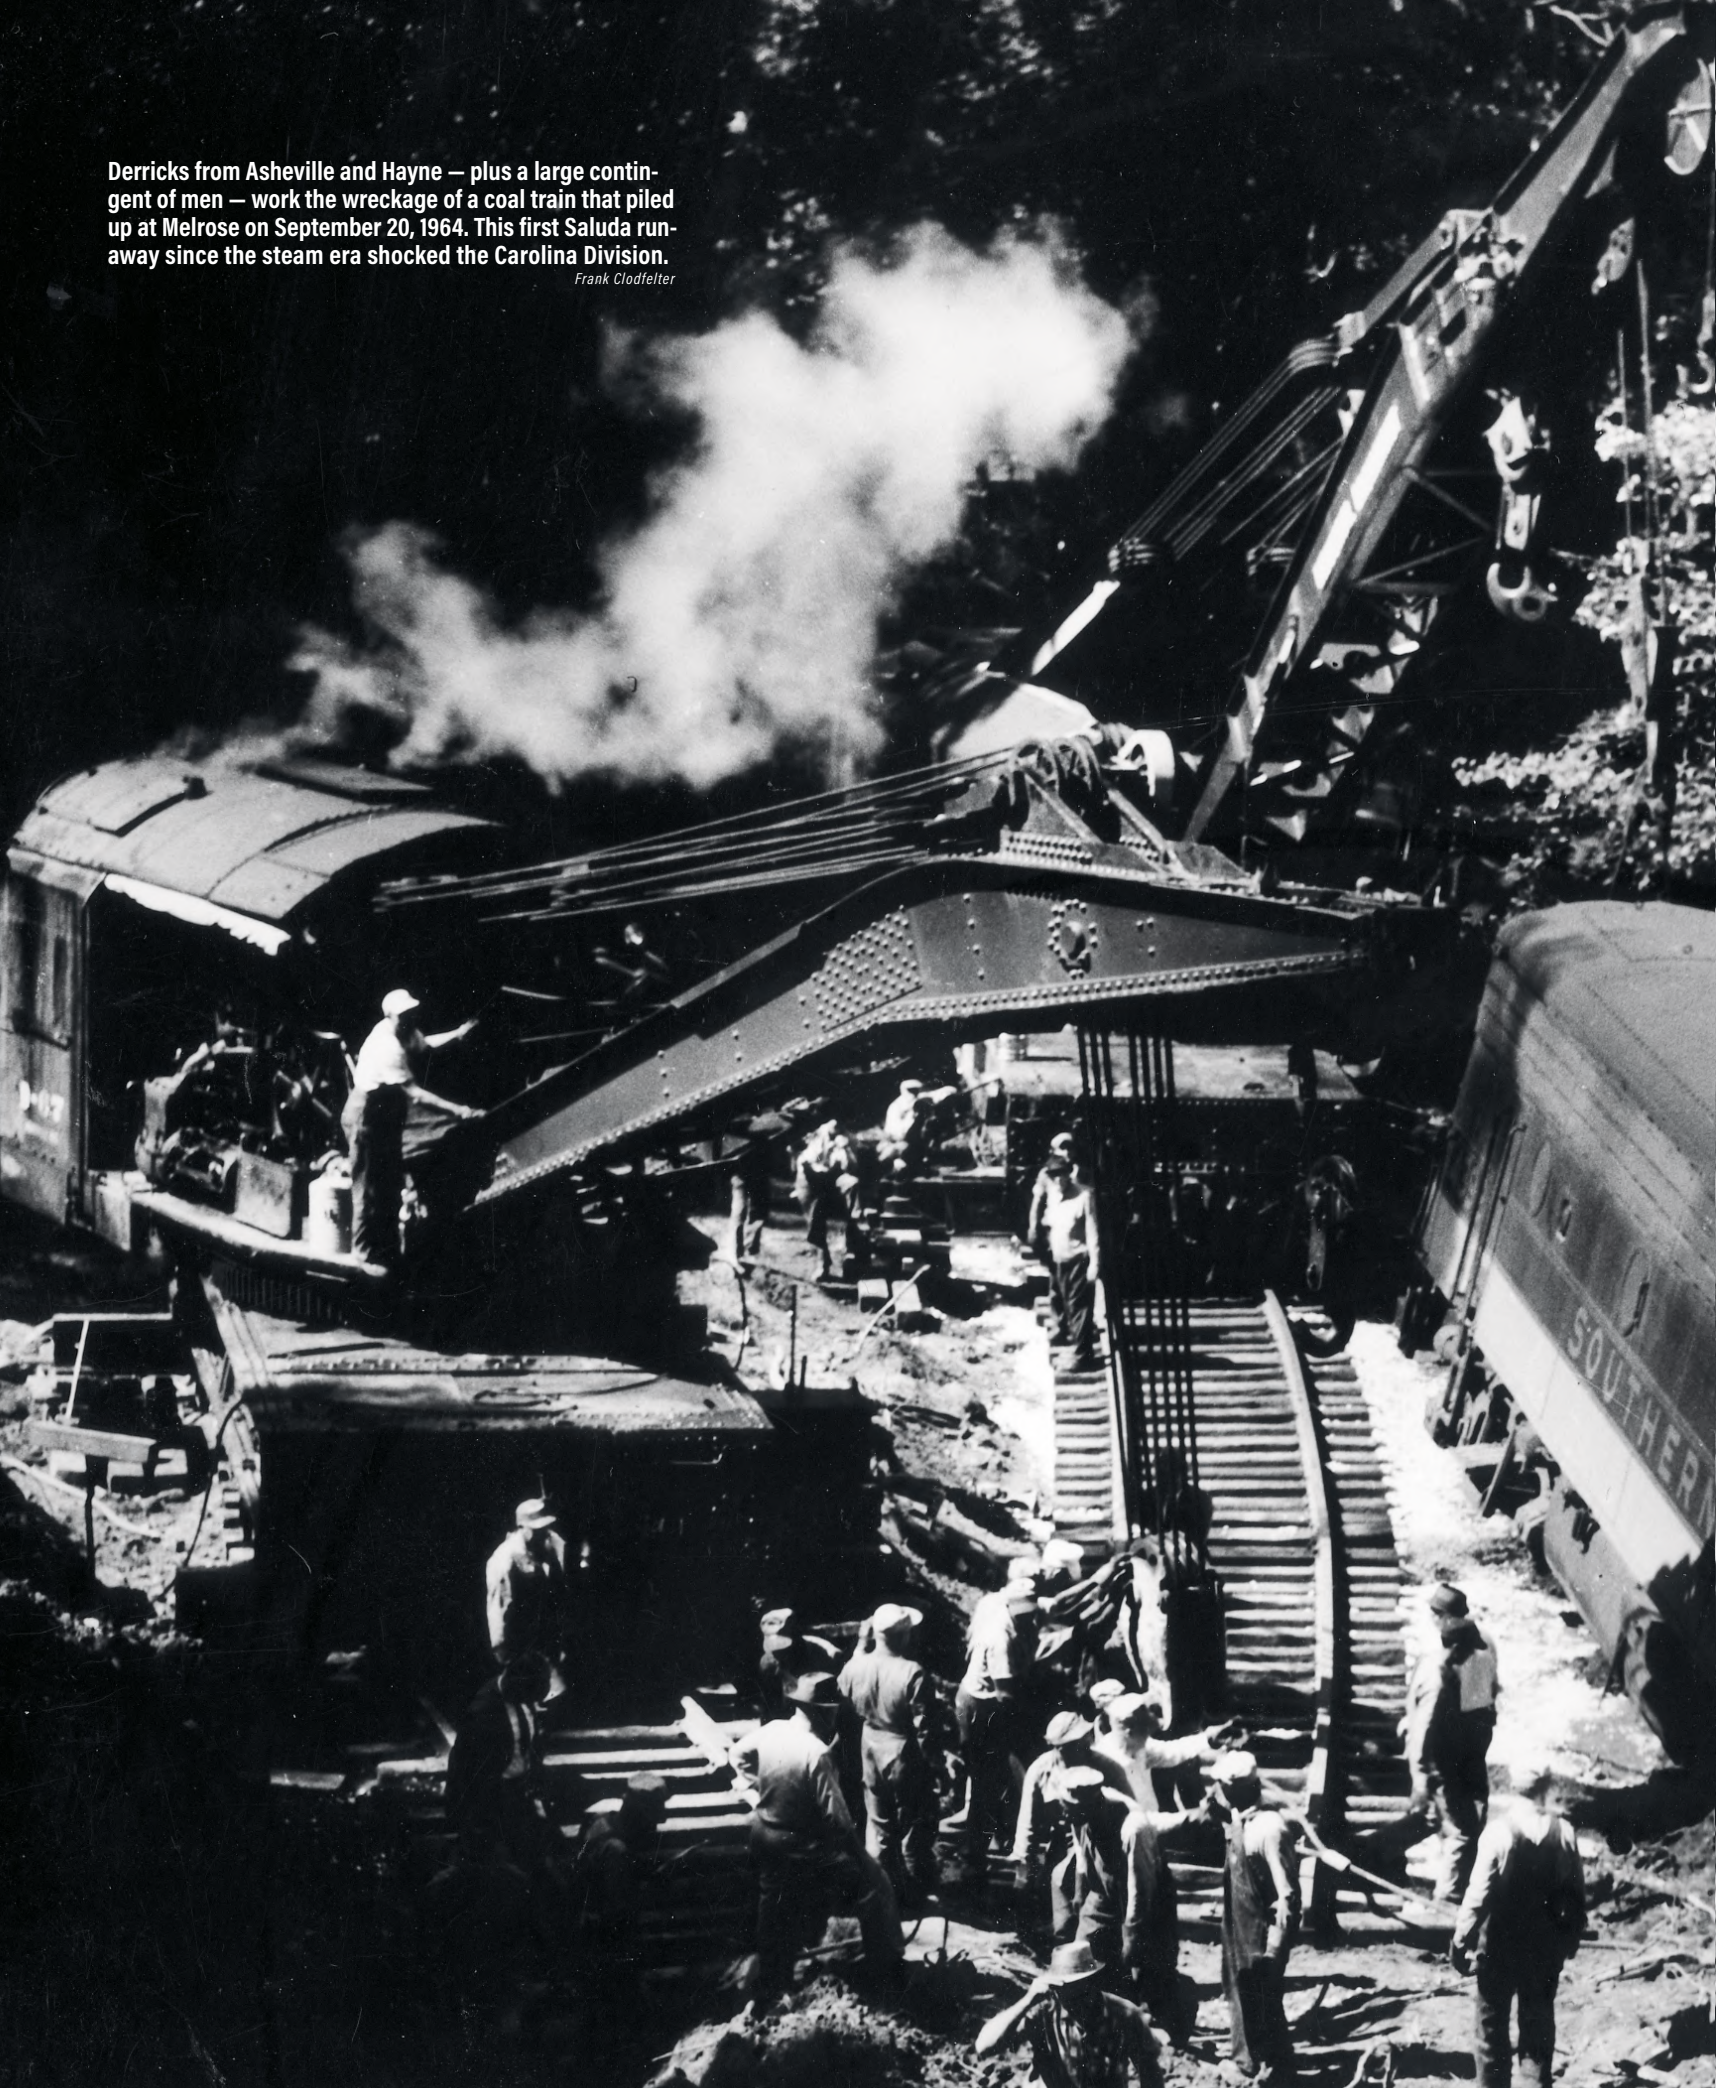
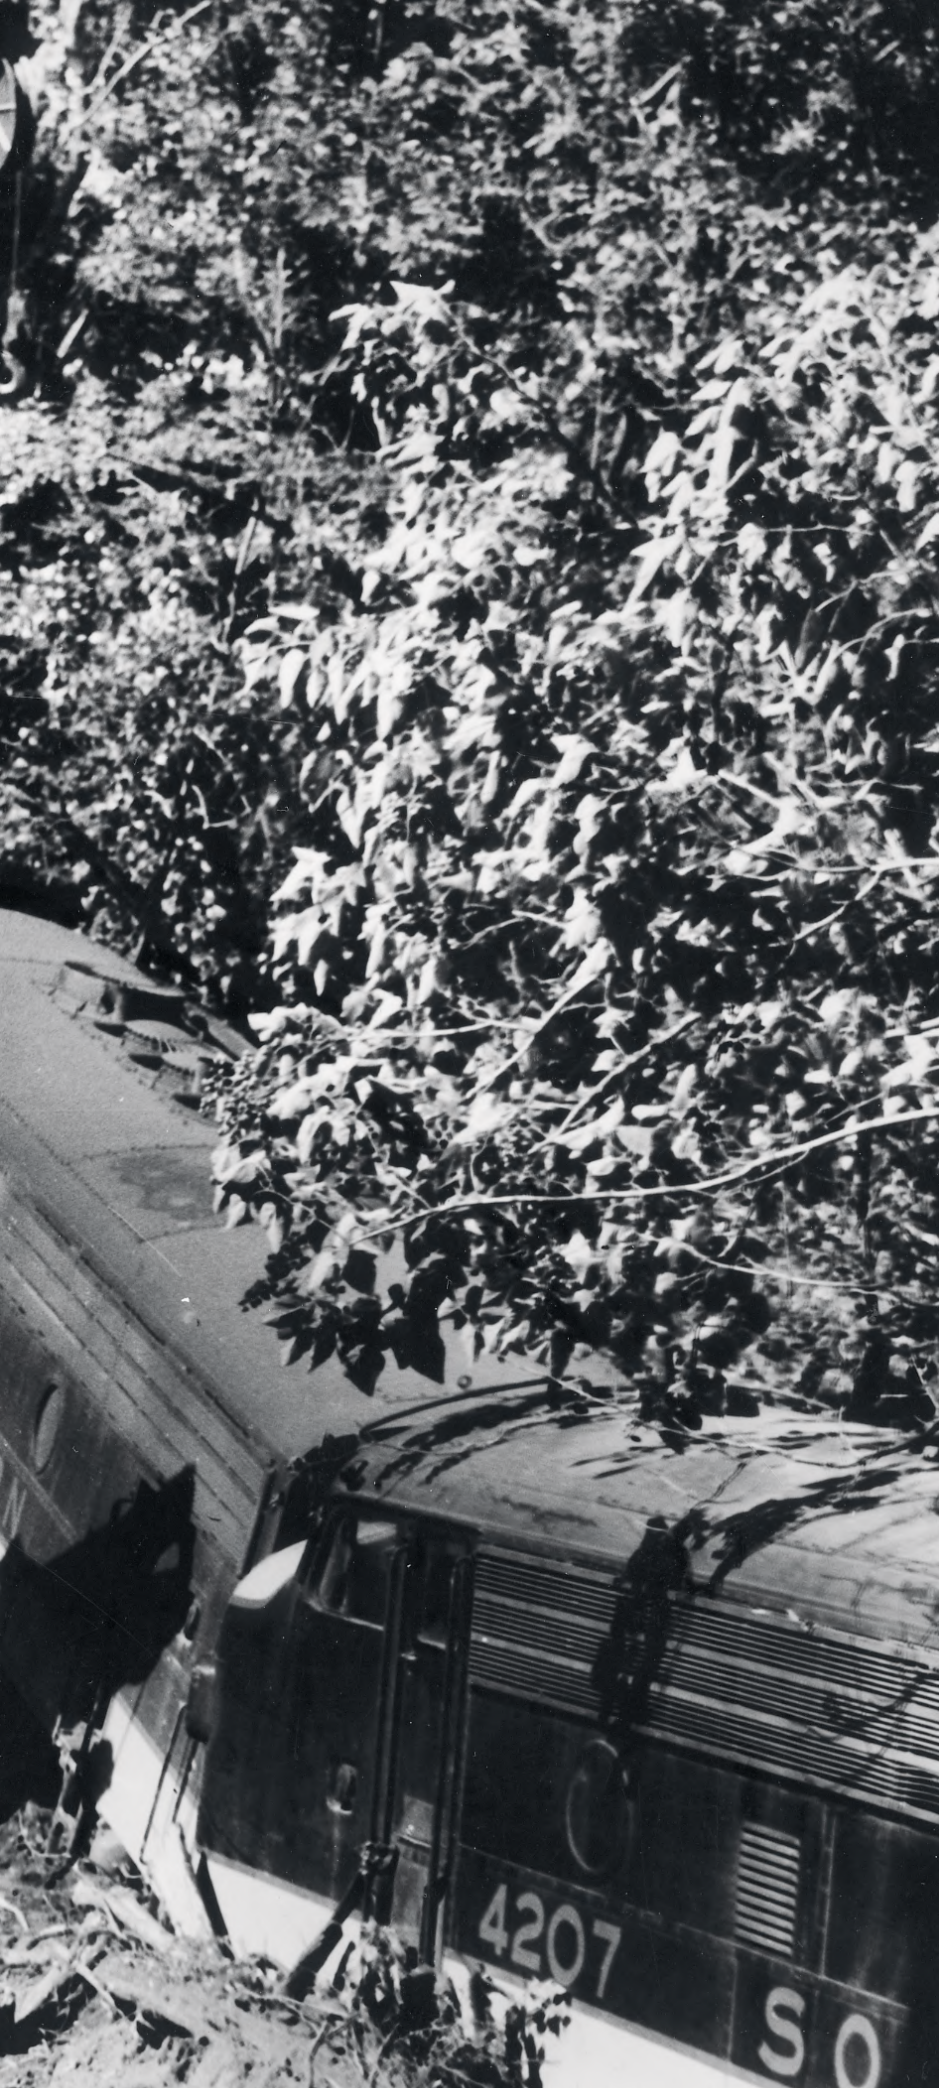
Derricks from Asheville and Hayne — plus a large contingent of men — work the wreckage of a coal train that piled up at Melrose on September 20, 1964. This first Saluda run-away since the steam era shocked the Carolina Division.

Of the 6,300-ton train’s 69 cars, the first 23 were turned over or derailed. Damage to the locomotives totaled \$69,500.

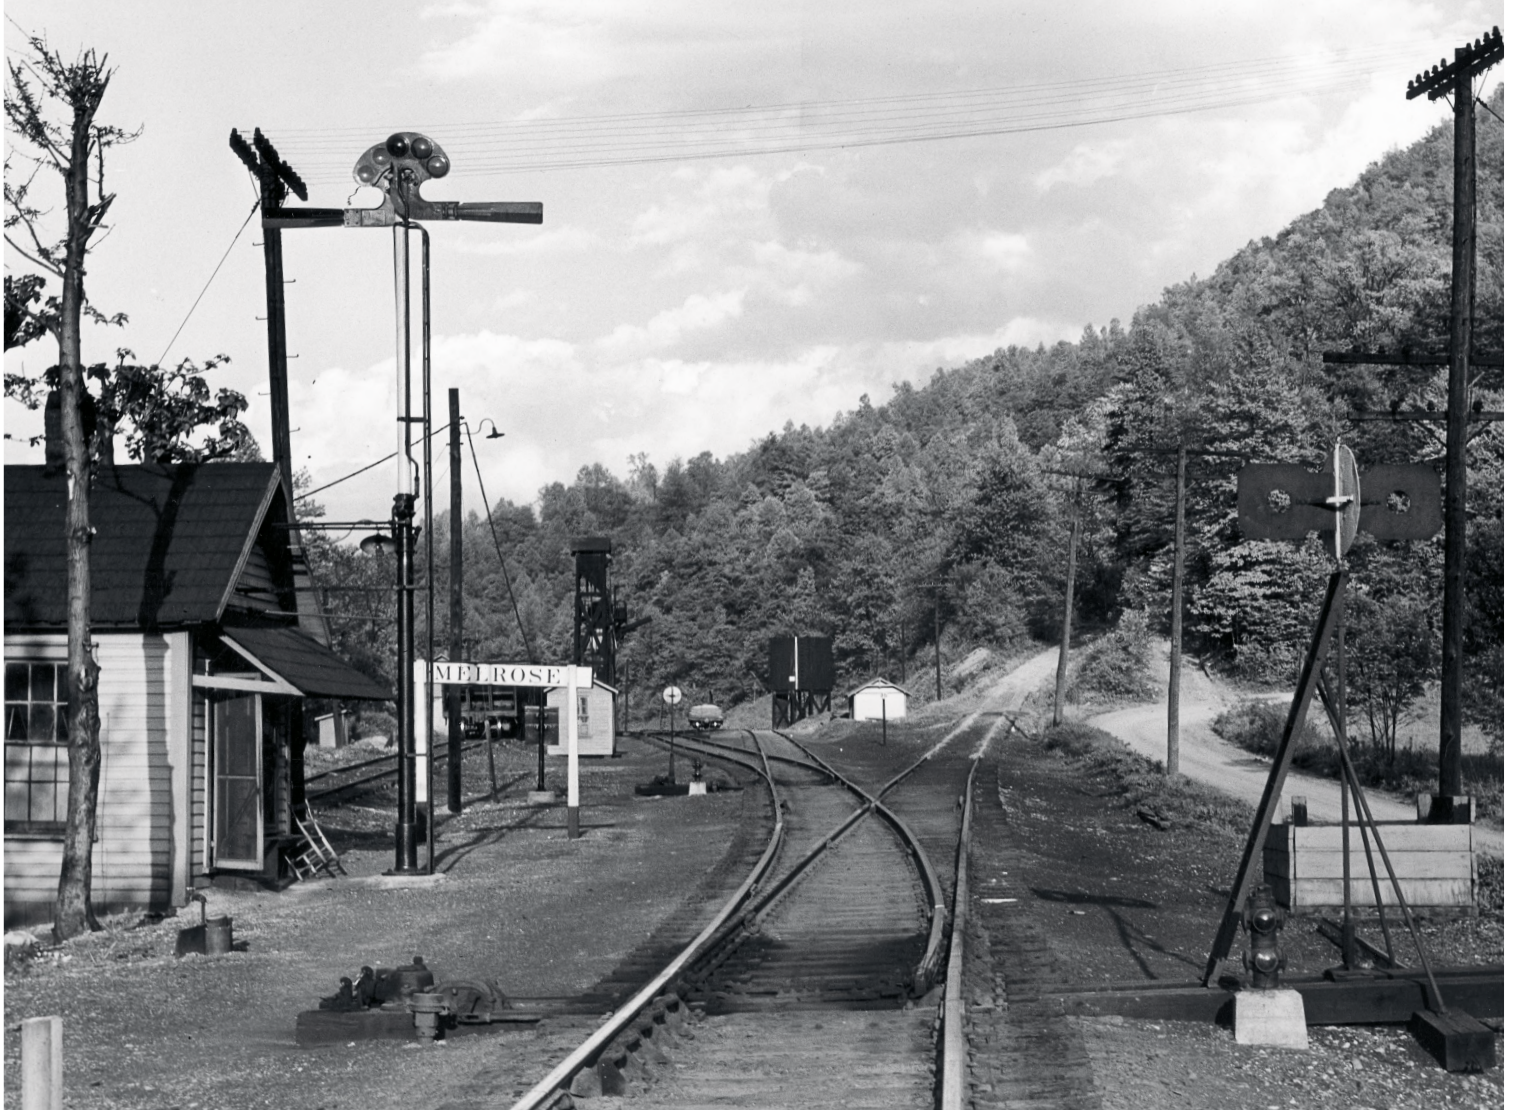
An eastward view at Melrose shows the extensive facilities at the base of Saluda Grade in April 1948. Around the left-hand bend beyond the water tower is Slaughter Pen Cut, where a carload of livestock perished in an 1893 runaway. The switch target for Safety Track No. 2 is mounted high for better visibility.

the grade, opposite the operator’s shanty at Melrose. This track was located several thousand feet west of Slaughter Pen Cut and had grades that varied from 5.5 to 10.3 percent. This track was also heavily sanded.
