For Want of a Nail

The Wreck of the City of New Orleans

By Robert P. Schmidt

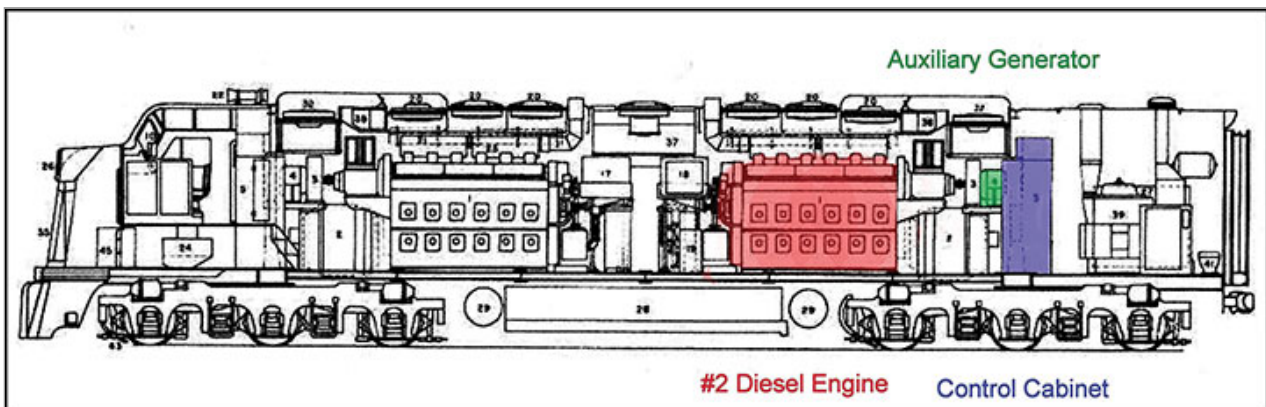
A drawing showing the arrangement of equipment in an E-series Electro-Motive passenger locomotive. The number 2 (rear) diesel engine is shaded in red, the auxiliary generator is shaded in green, and the electrical control cabinet is shaded in blue.

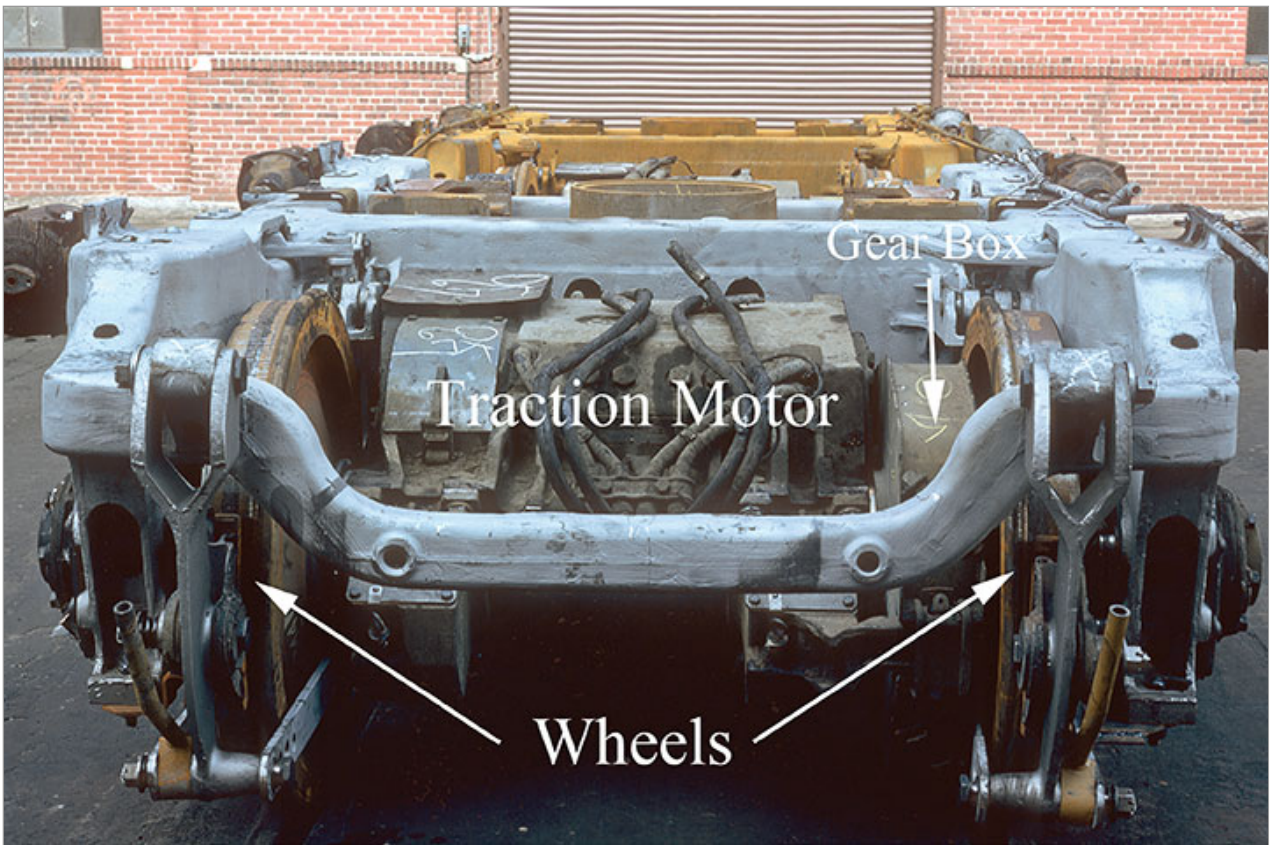
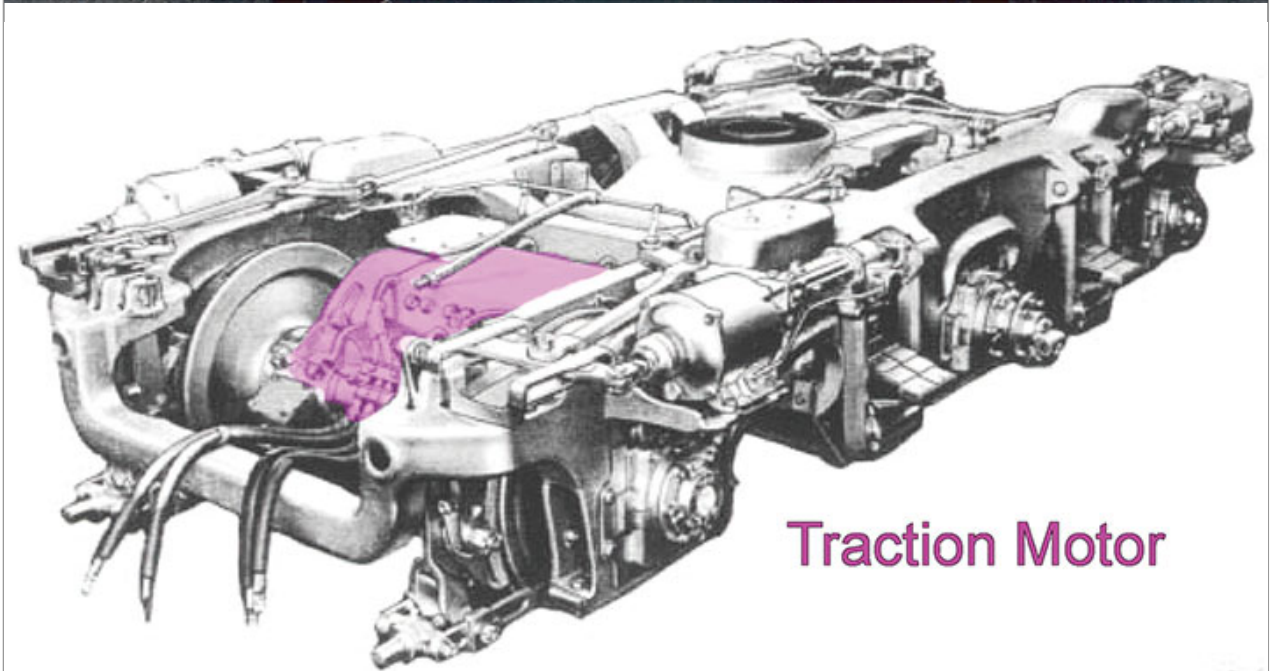
The traction motors are mounted in the locomotive truck as shown in the photo. The “commutator end” is on the left. In the lower image, we see how the closest traction motor (tinted in color) relates to the rest of the truck assembly.

A locomotive traction motor has two ends: the “commutator end” and the “pinion end” (the latter is geared to the wheels). The motor itself is wound around the armature shaft, which rotates at up to 2,800 rpm when the motor is being used. The armature is quite heavy, and is supported at both ends by roller bearings. The bearings at the commutator end were held in place by a retainer plate, which in this case was screwed into the end of the armature shaft. (This design was found in only about 10 percent of shafts at the time of the rebuild; the attachment method had been changed for new motors in the early 1950s.) To prevent the retainer plate from accidentally unscrewing, two smaller set screws were placed through the plate and tightened against the end of the shaft. The set screws had sharp O-shaped ends, which would dig into the shaft and keep the plate in place. If properly installed, this plate was not going anywhere. However, in this instance the evidence was clear that the set screws had not been not adequately tightened. The whole area was then covered with a heavy steel cap, so there was no practical way to examine the retainer plate or the set screws. When the motor was installed in the 4031, the only force holding the plate and bearings in place at the commutator end was the friction between the threads of the screw-in plate and the shaft. So long as that condition prevailed, which continued for two months, the train would not experience any problem. But then, a string of events—both related and unrelated to the traction motor—began:

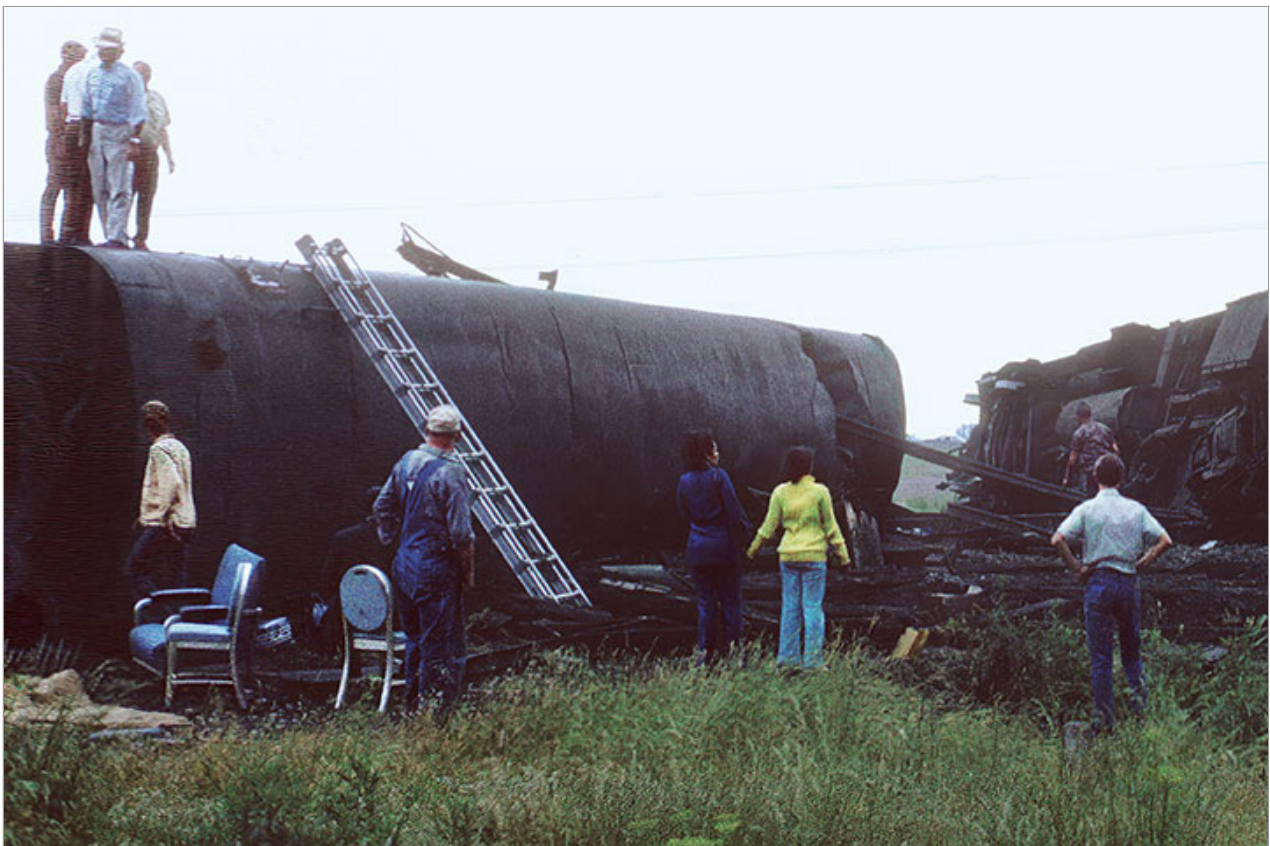
First responders, nearby townspeople, and “just folk” all pitched in to rescue victims from the wreck. Some passengers were sheltered in area homes.

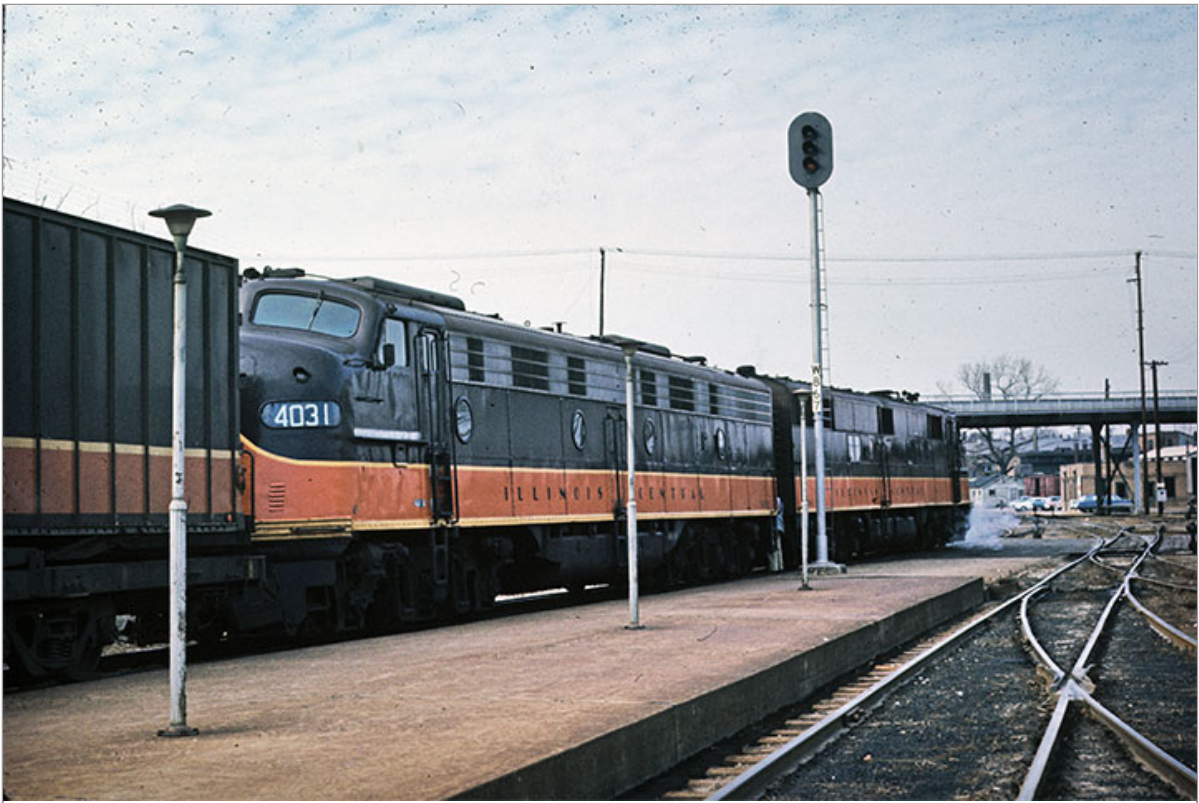
Illinois Central E9 number 4031 is the trailing unit on the westbound Land O' Corn at the Rockford, Ill., station in 1967. Advancing ahead to that tragic day in 1971, the 4031 was also set to be a trailing unit on the City of New Orleans, but at the last minute, the City's locomotive set had to be turned, thus putting the 4031 in the lead—and the rest is history.
